# **Asbestos Survey for**

**JJ Holmes Properties**

Ormsby - Common way areas  
Corner of Grange & Stanley Road  
Sutton  
Surrey  
SU1

<i>777 Environmental</i>	Project Number:	AE 820
	Survey Date:	24 May 2004
	Printed On:	17 June 2004
	Page:	Page 1 of 1

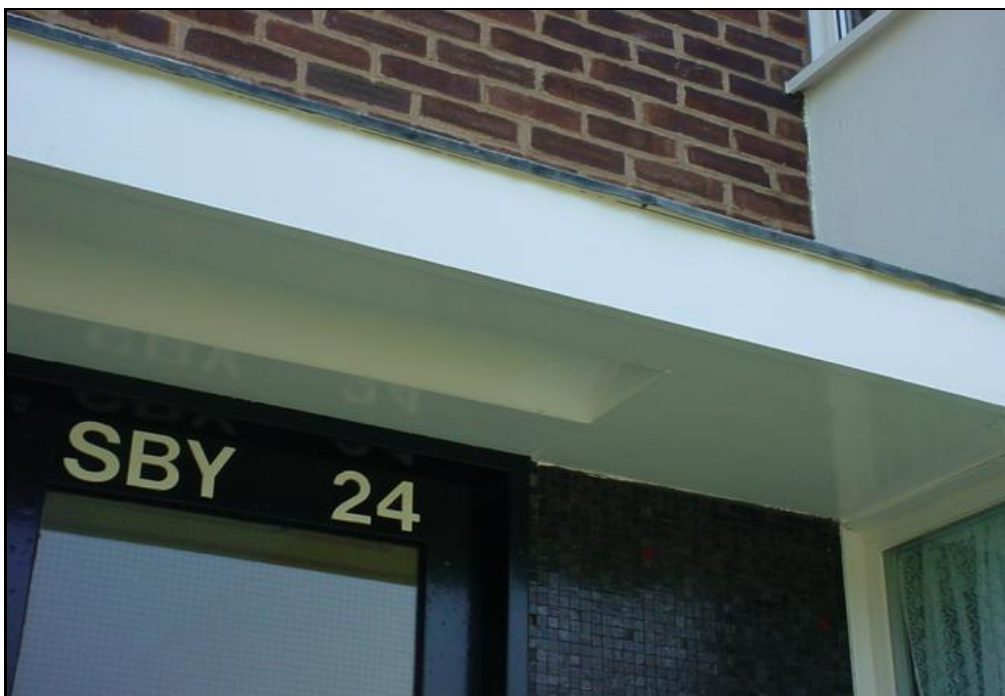
The soffit to the entrance is made of timber.

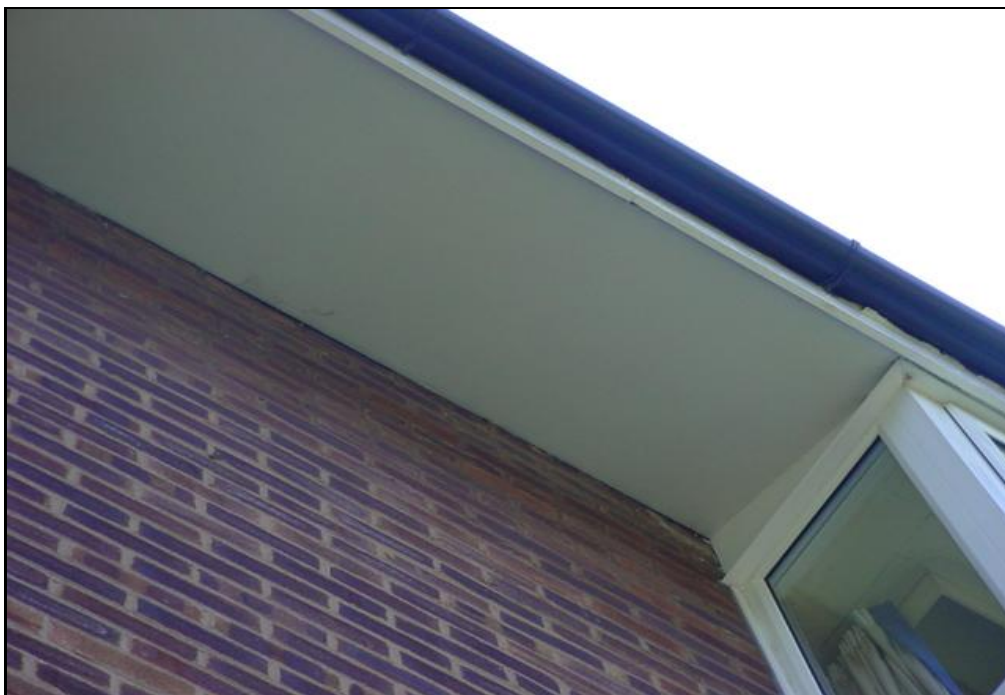
Material Risk Band: Low Risk

Priority Risk Score: 5

The soffit could not be investigated as it is too high for a four metre ladder.

Should works or activities that may disturb the soffit become necessary we would recommend that a sample of the soffit is taken and analysed. In the meantime the soffit should be visually inspected for damage periodically, as recommended in the material assessment.

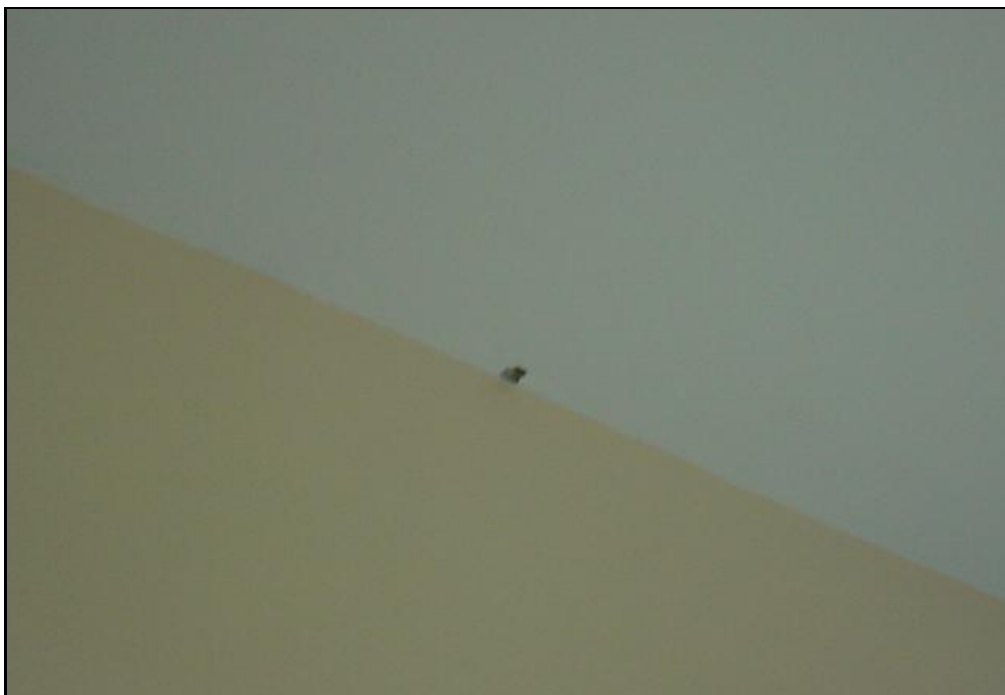
The ceiling is made of plaster.

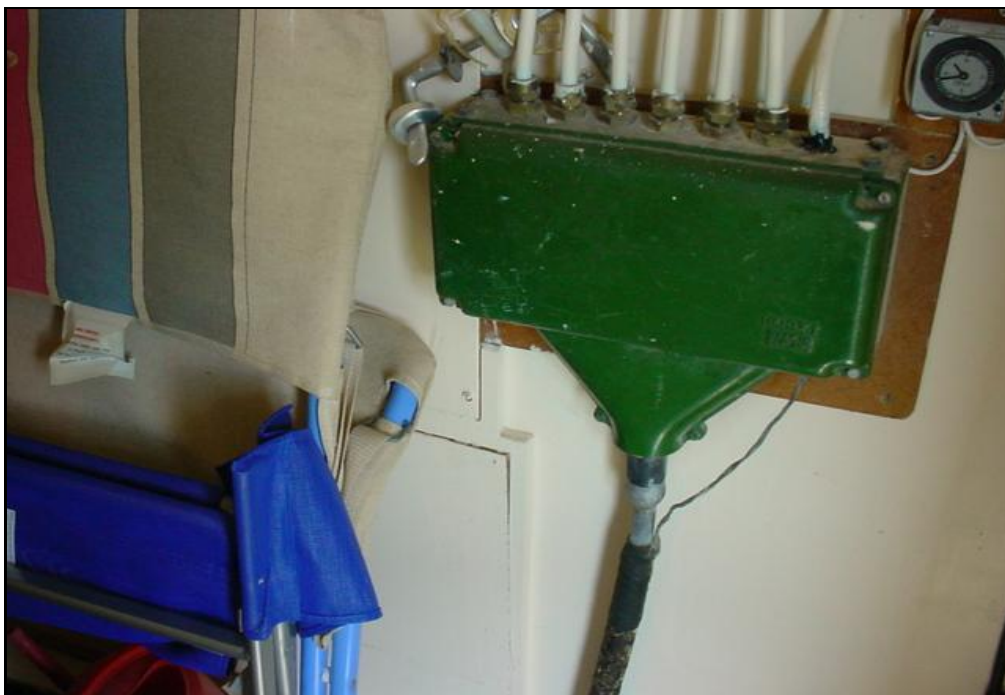
Priority Risk Score: 2

The electrics and electrical cable can contain asbestos materials. These can not be investigate further for safety reasons.

- 2 Electrical items can contain asbestos materials but these should only become an issue if major electrical works, refurbishments or demolitions become necessary. Qualified electrical engineers should be aware of the risks and all the while the electrics are live no other persons should go near the electrics.  
Fire doors also may contain asbestos materials but the only way to find this out is to damage the door which destroys its fire retarding properties.

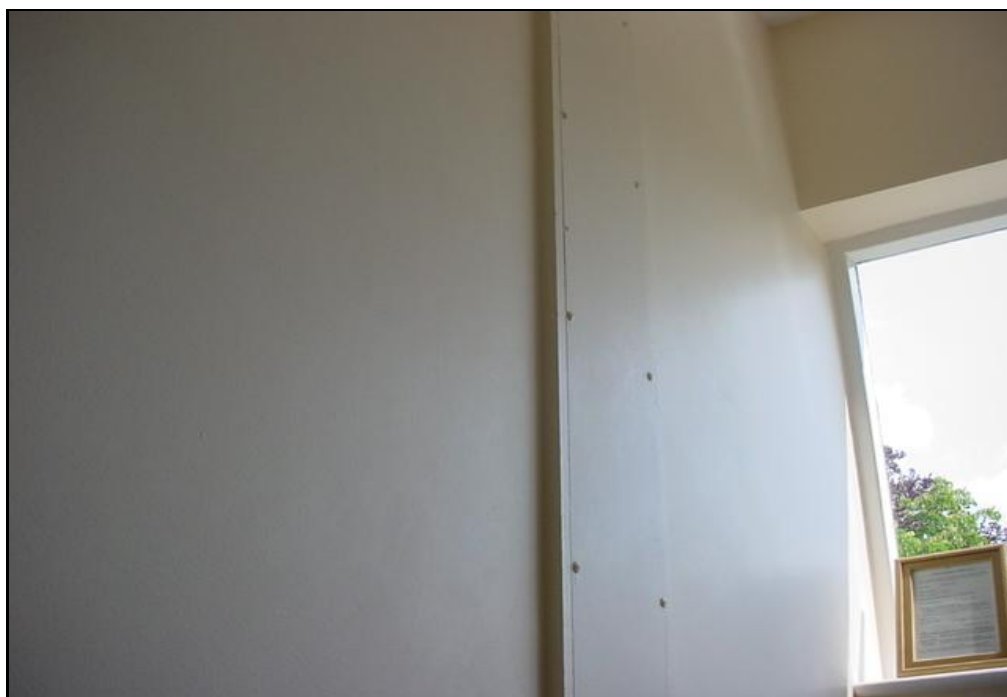
The panel to the riser is made of hardboard.

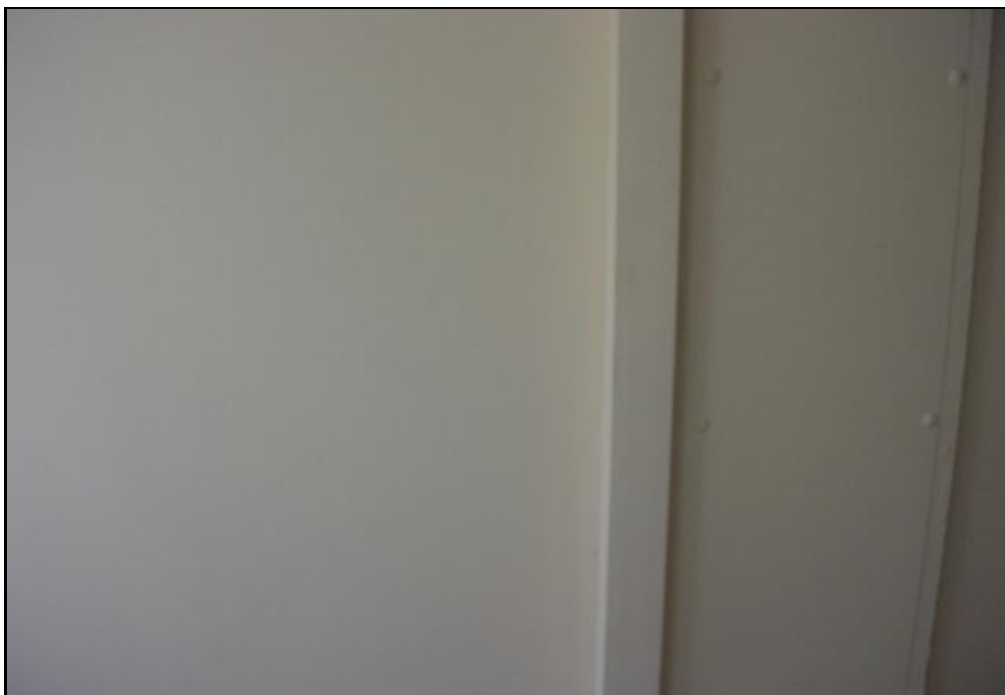
The electrical cable conduit boxing is made of plastic.

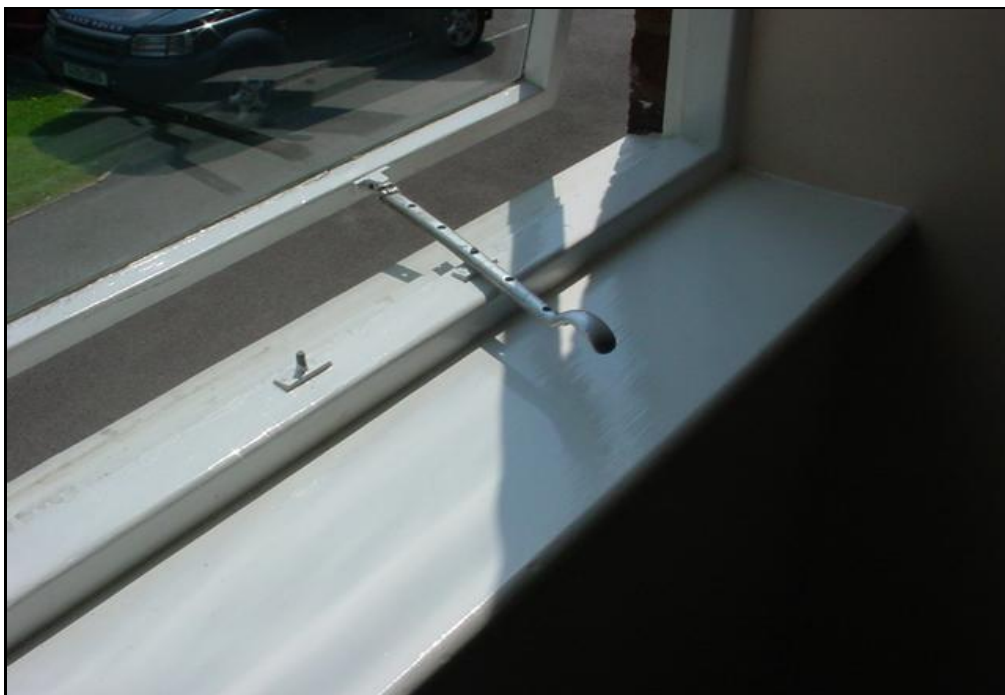
The window sills are made of timber.

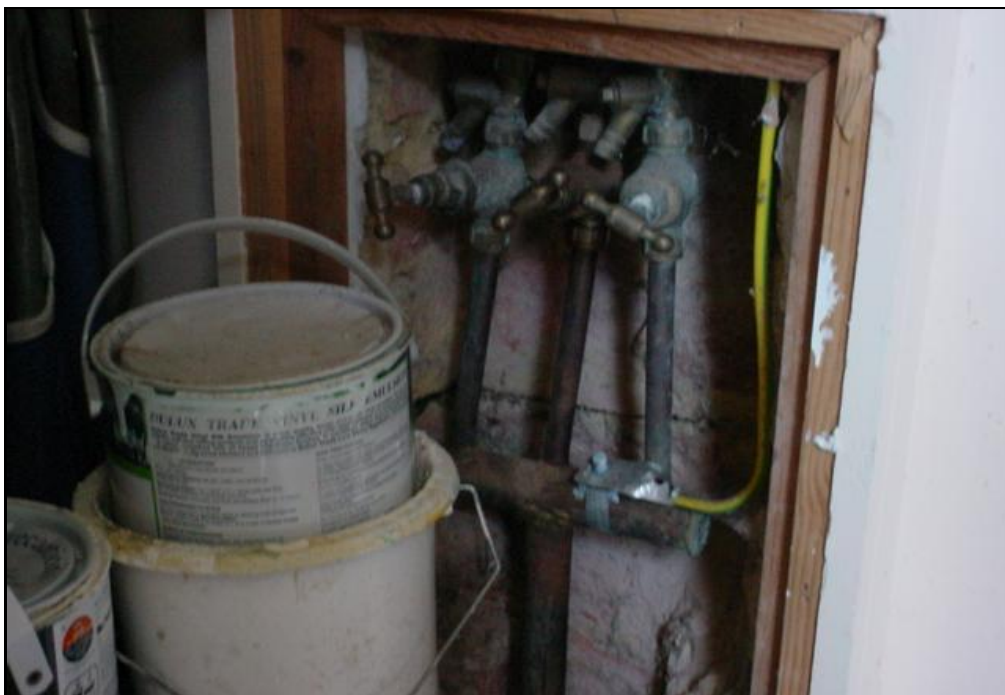
There were no asbestos materials observed to the store cupboard although there were some electrics present which can contain asbestos materials.

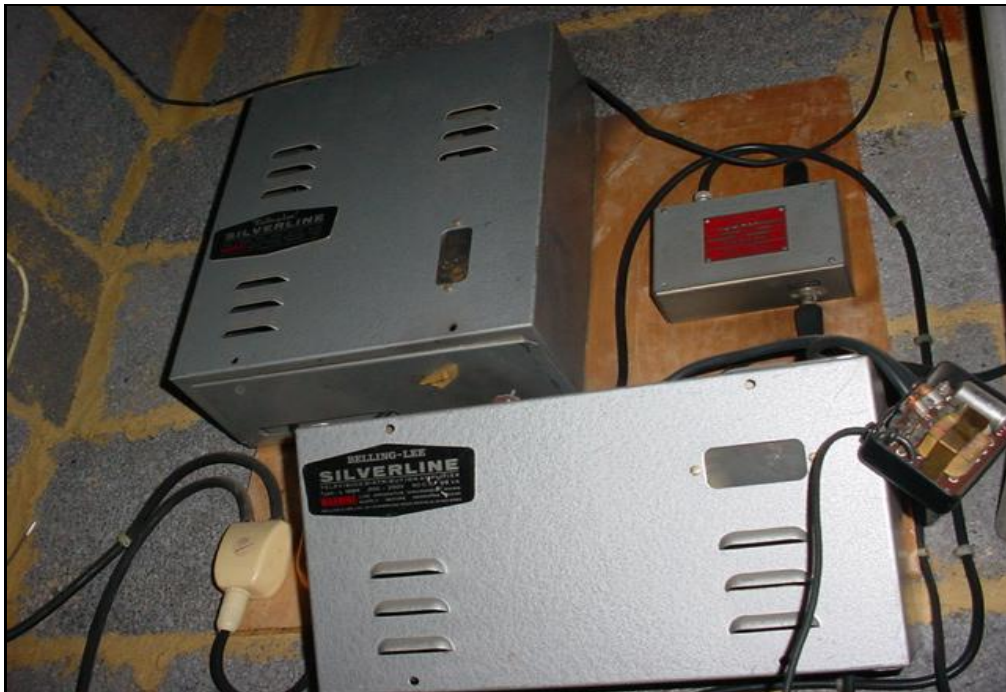
Material Comments:	The antenna to the roof space is backed by hardboard panels. No asbestos materials were found to the roof space.
--------------------	--

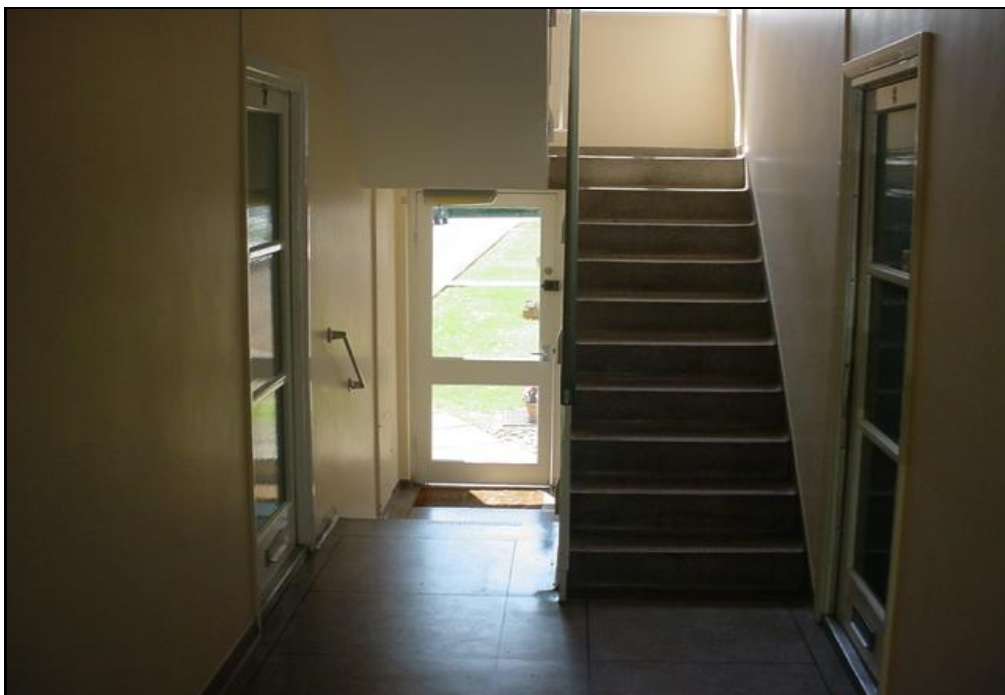
Material Comments: The common way area is identical in structure and design to the previous and is constructed of the same materials..

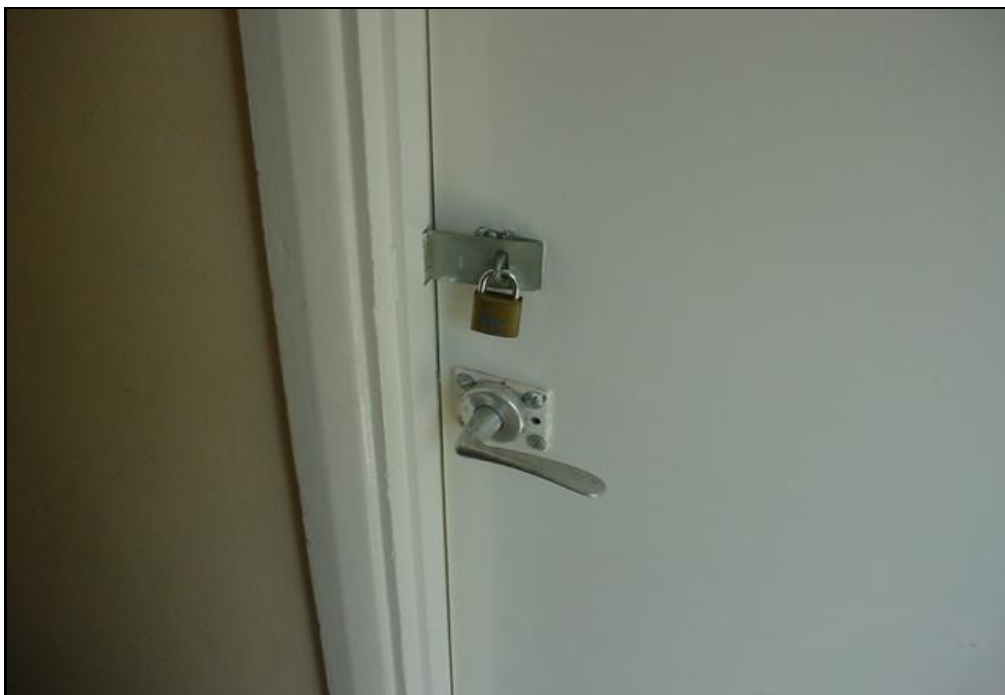
Material Risk Score: 0  
Material Risk Band: Not Applicable  
Priority Risk Score: 4

Material Comments: The store cupboard lock had been changed and could not be accessed. It may be presumed to contain asbestos materials.

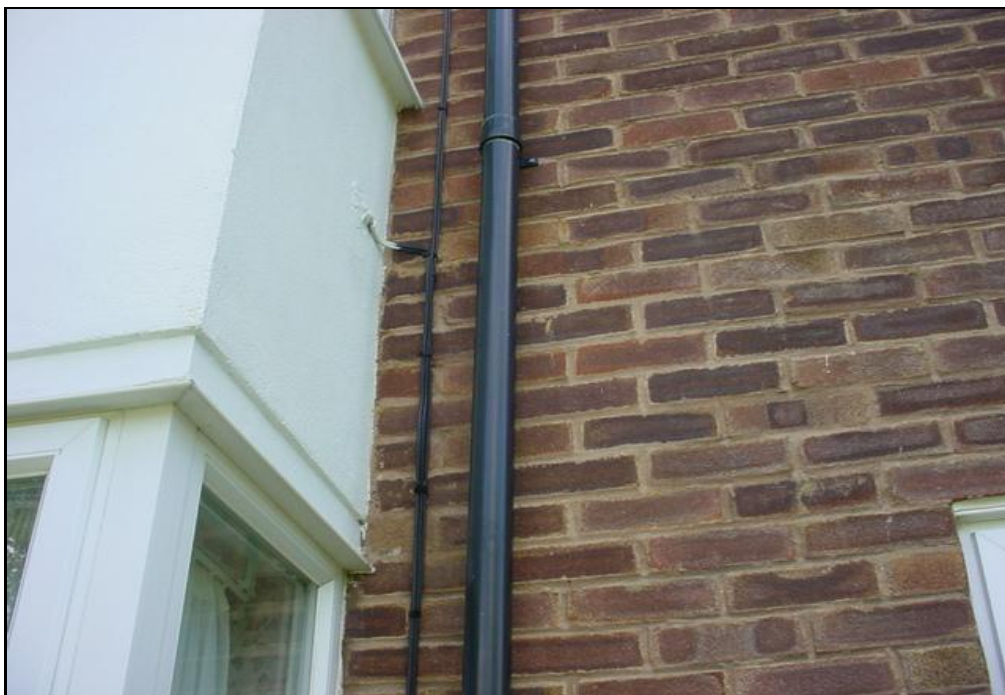
The downpipes to the building are made of plastic.

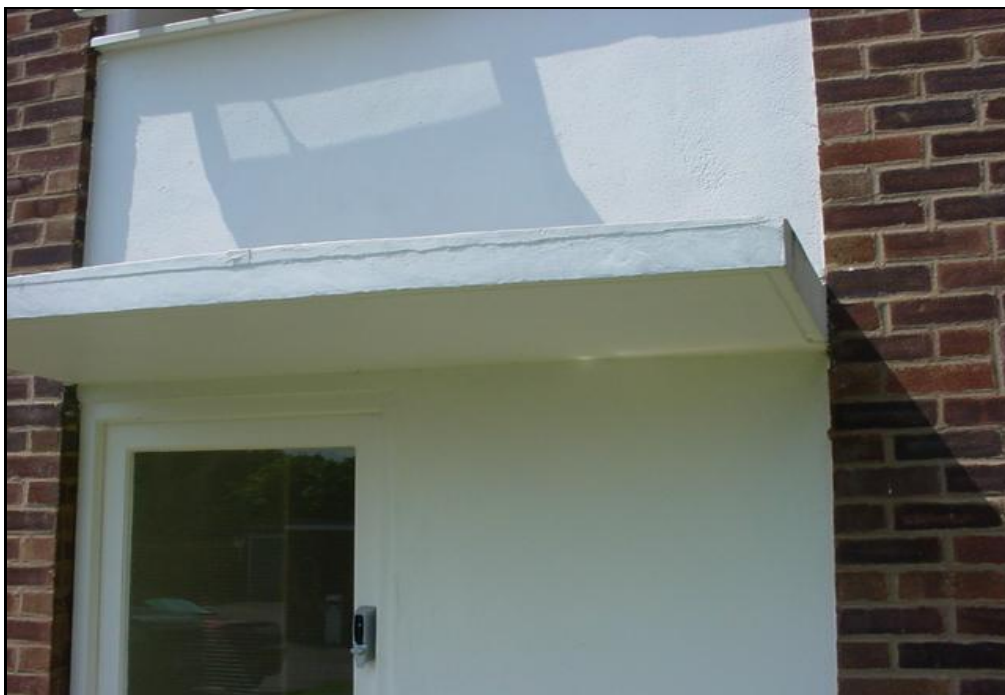
The porch soffit is made of concrete.

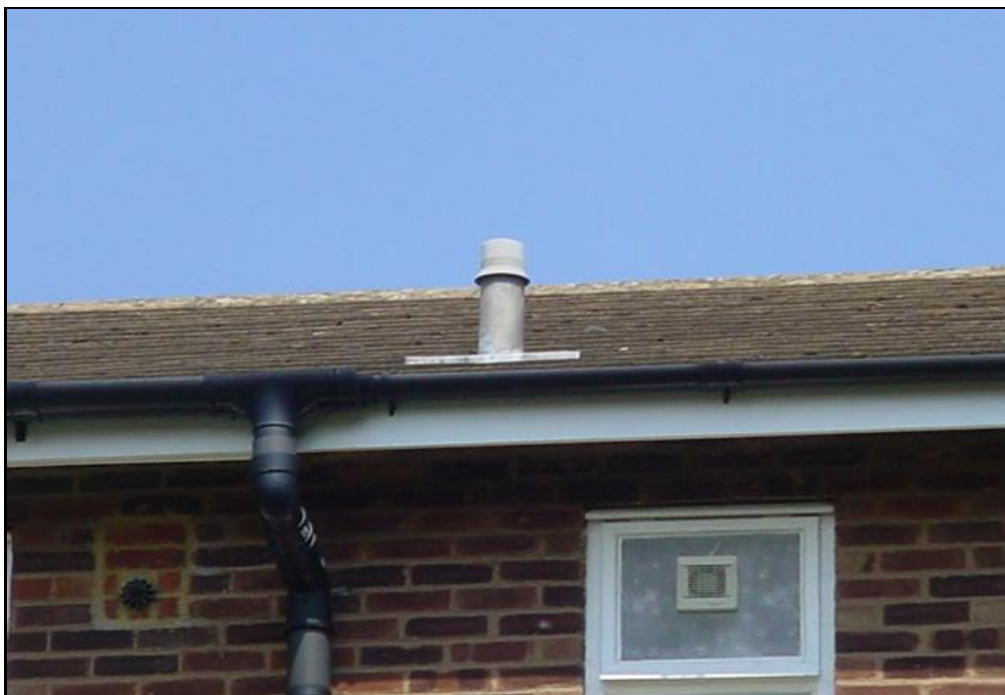
Material Risk Band: Low Risk

Priority Risk Score: 2

The flue pipe was too high for the surveyor to access and could not be fully investigated. It may be made of asbestos cement.

The only other material which is suspected to be made of asbestos is the small section of flue pipe visible to the roof. Once again due to its position the chances of disturbance are very low. Should there for any reason be a chance of disturbance to the material then once again we would recommend it is sampled and tested to find out if it is an asbestos material or not. The flue pipe should be examined for damage periodically.

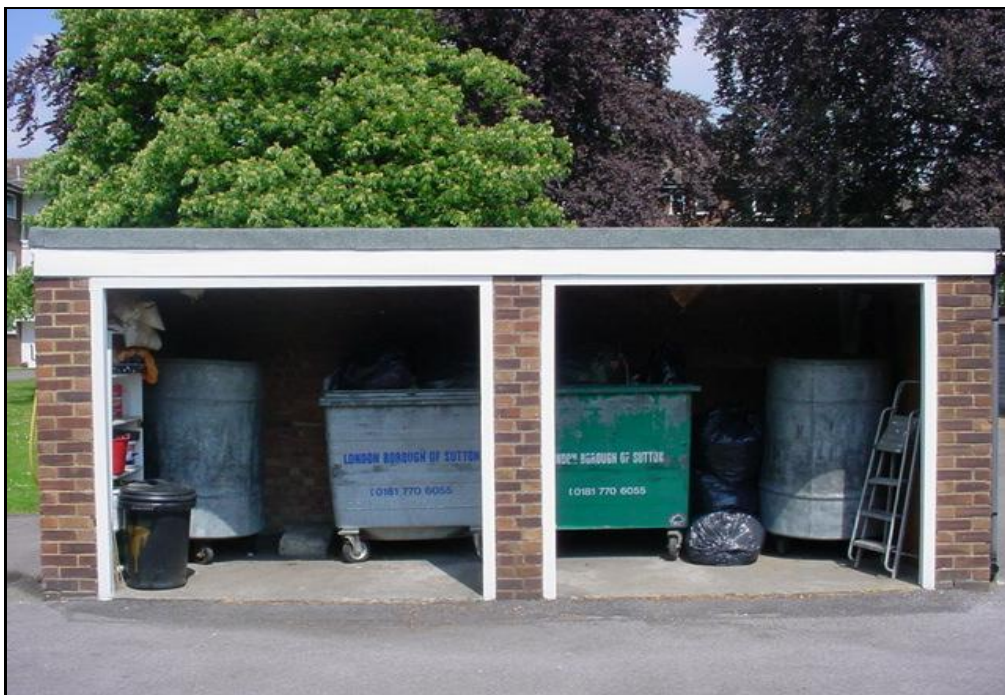
The refuse storage area was investigated and no asbestos materials were observed.

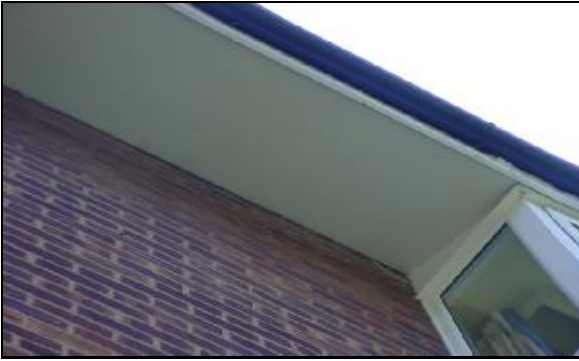
Location ID:	654

Location Ref:	0	
Product:	Soffit	
Floor:	Roof level	
Room:	External	
Area:	All	
Surveyor Name:	Kevin Wild	
Drawing Ref:		
Asbestos:	Yes	<b>Priority Comments:</b> The soffit is unlikely to be disturbed unless maintenance works at roof level are carried out.
Date:	24 May 2004

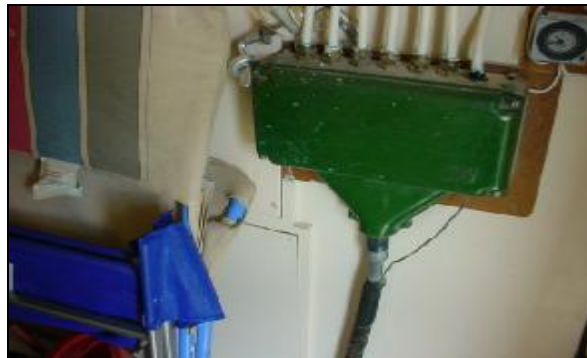
Location ID:	656
Location Ref:	0
Product:	Electrics
Floor:	Ground floor
Room:	Store cupboard
Area:	Flats 19-24
Surveyor Name:	Kevin Wild
Drawing Ref:	
Asbestos:	No
Date:	24 May 2004

The electrics or electrical cable are unlikely to be disturbed by anyone other than qualified electricians.

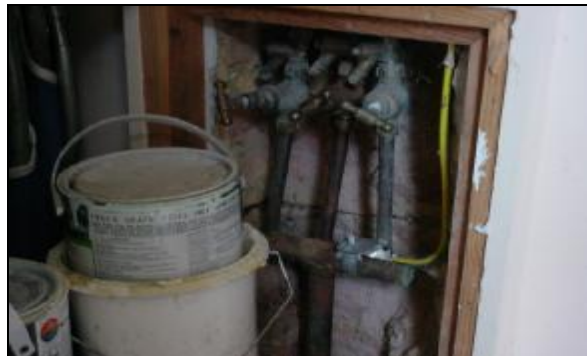
Location ID:	660
Location Ref:	0
Product:	Various
Floor:	Ground floor
Room:	Store cupboard
Area:	Flats 12-18
Surveyor Name:	Kevin Wild
Drawing Ref:	
Asbestos:	No
Date:	24 May 2004

The electrics or electrical cable are unlikely to be disturbed by anyone other than a qualified electrician.

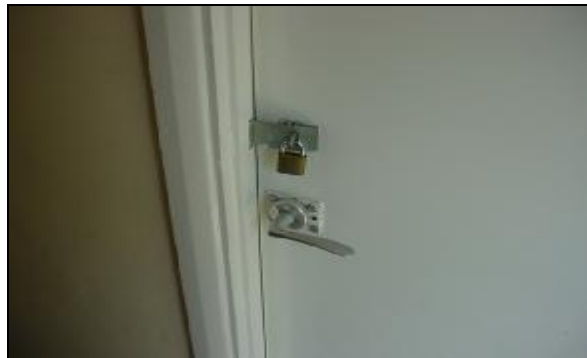
Location ID:	664
Location Ref:	0
Product:	Inaccessible area
Floor:	Ground floor
Room:	Store cupboard
Area:	Flats 1-6
Surveyor Name:	Kevin Wild
Drawing Ref:	
Asbestos:	No
Date:	24 May 2004

The store cupboard may contain asbestos materials of which exposure potential and likelihood of disturbance is not known for certain and is presumed to be of a high risk.

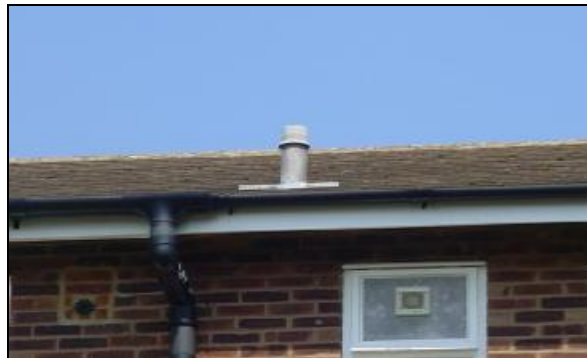
Location ID:	667
Location Ref:	0
Product:	Flue pipe
Floor:	Roof area
Room:	External
Area:	Flats 1-6
Surveyor Name:	Kevin Wild
Drawing Ref:	
Asbestos:	Yes
Date:	24 May 2004

The priority assessment for the flue pipe is based on any maintenance works at roof level.

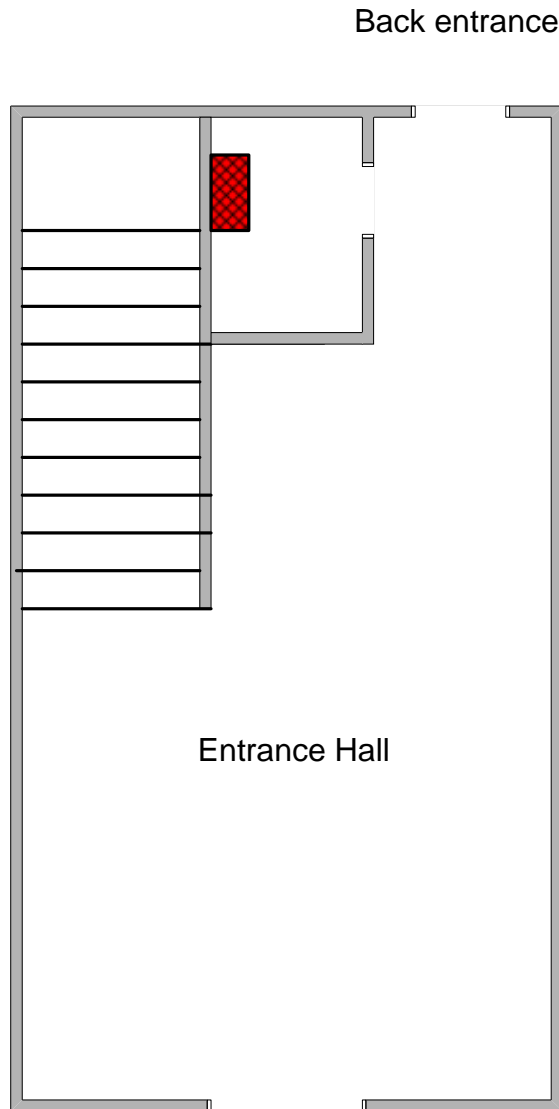
## Common way areas

Electrical cable  
sheathing may contain  
asbestos materials

Suspected asbestos  
soffit

Suspected asbestos  
cement flue pipe
